# Procedures for the Evaluation of Sheet Membrane Waterproofing

SPECIAL REPORT

# Special Report 99-11

Prepared for  
NEW ENGLAND TRANSPORTATION CONSORTIUM

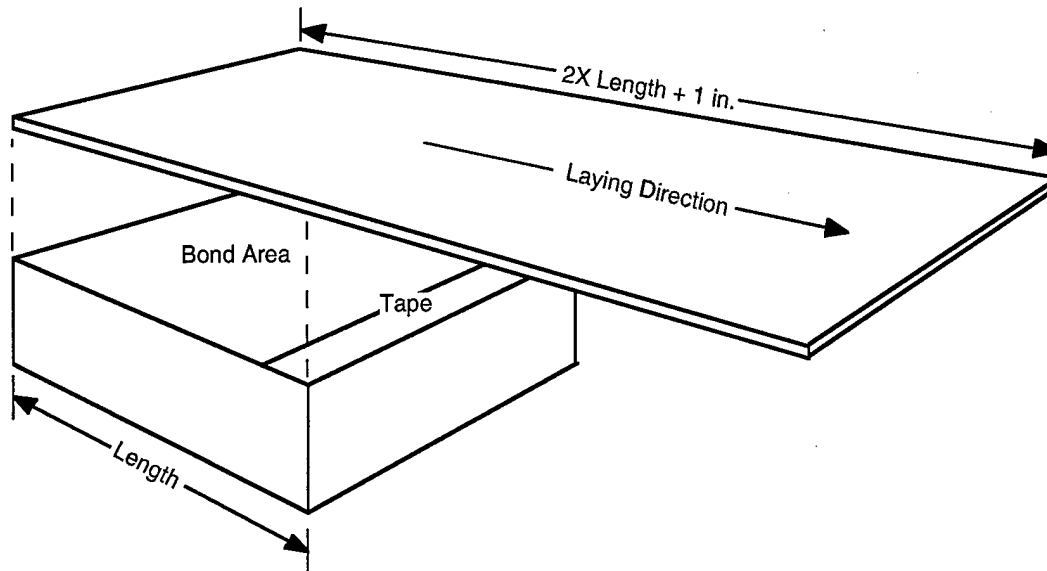
Figure 1. Fabrication of test specimens.

- At room temperature, mix one weight of Type I portland cement with two weights of Ottawa sand (20–30 grade) according to ASTM C305.
- Cast mortar into 6- × 6- × 21-in. (15- × 15- × 53-cm) molds and cover with sheet of plastic.
- After 24 hours, strip molds and cure mortar beams in room-temperature limewater for 14 days.

- Cut beams into 6- × 6.38-in. (15.2- × 16.2-cm) slices.
- Sand slices (slabs) with 24-grit silicon-carbide sandpaper until surface is flat and all saw marks are removed.
- Oven dry the mortar slabs at 220°F (104°C) for 24 hours.
- Clean sanded surface with dry, stiff fiber bristle brush.
- Place 0.75-in. wide strip of tape across one end of slab.
- Apply primer to the test surface.
- Allow primer to cure to a tack-free finish.
- Apply membrane according to manufacturers' instructions.
- Condition specimens at approximately 70°F (21°C) and 50% RH (relative humidity) for a minimum of 14 days.
- Cut membrane into five 1-in.- (2.5-cm) wide strips through to the mortar with a sharp razor knife.
- Start cuts 0.50-in. (1.3 cm) from edge of slab.

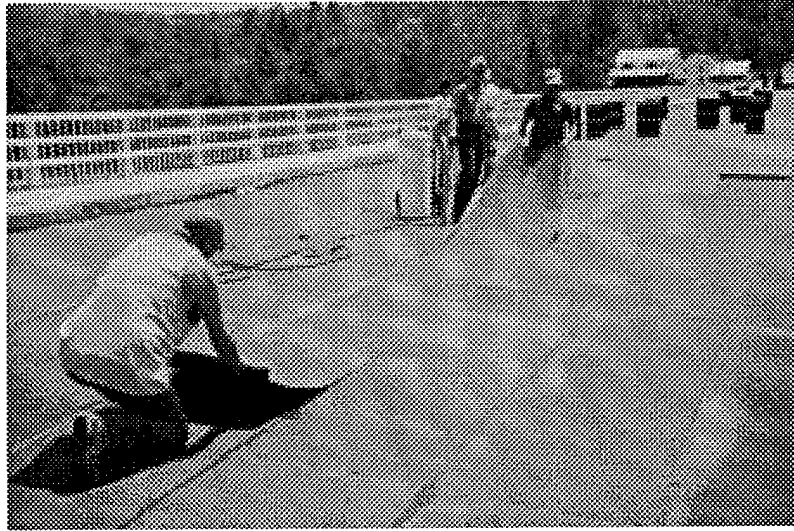
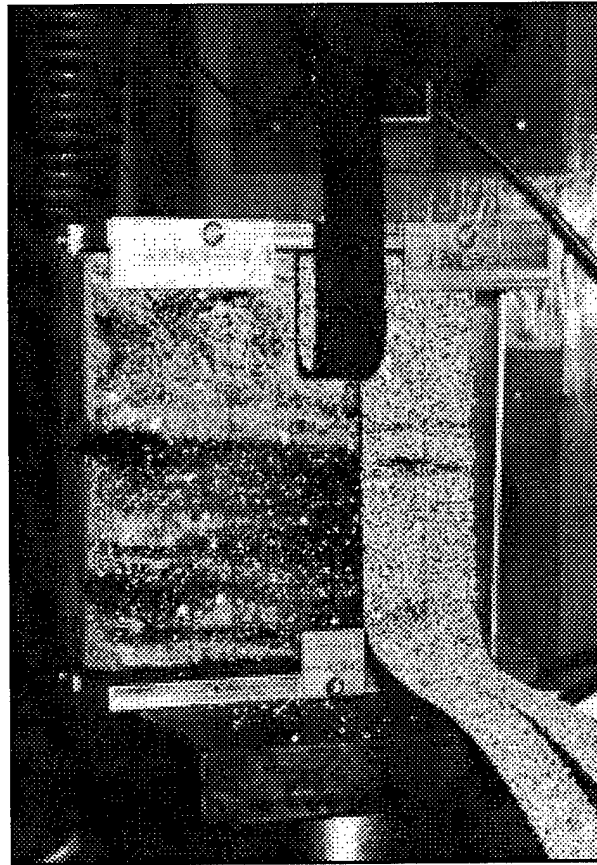
*Figure 2. Typical installation and adhesion test setup.*

Figure 2 shows the test setup. Five strips of membrane were peeled off each slab back at an angle of 180° at a grip separation rate of 4 in. (10.2 cm)/min. Force and grip displacement were recorded for each strip. Slippage in the grips and membrane stretching are discounted, grip displacement is exactly twice membrane displacement. Before discussing the significance of the adhesion test data, we will first consider the mechanics of blistering.

*a. Installing a membrane.*

*b. Peeling membrane strip from mortar slab.*

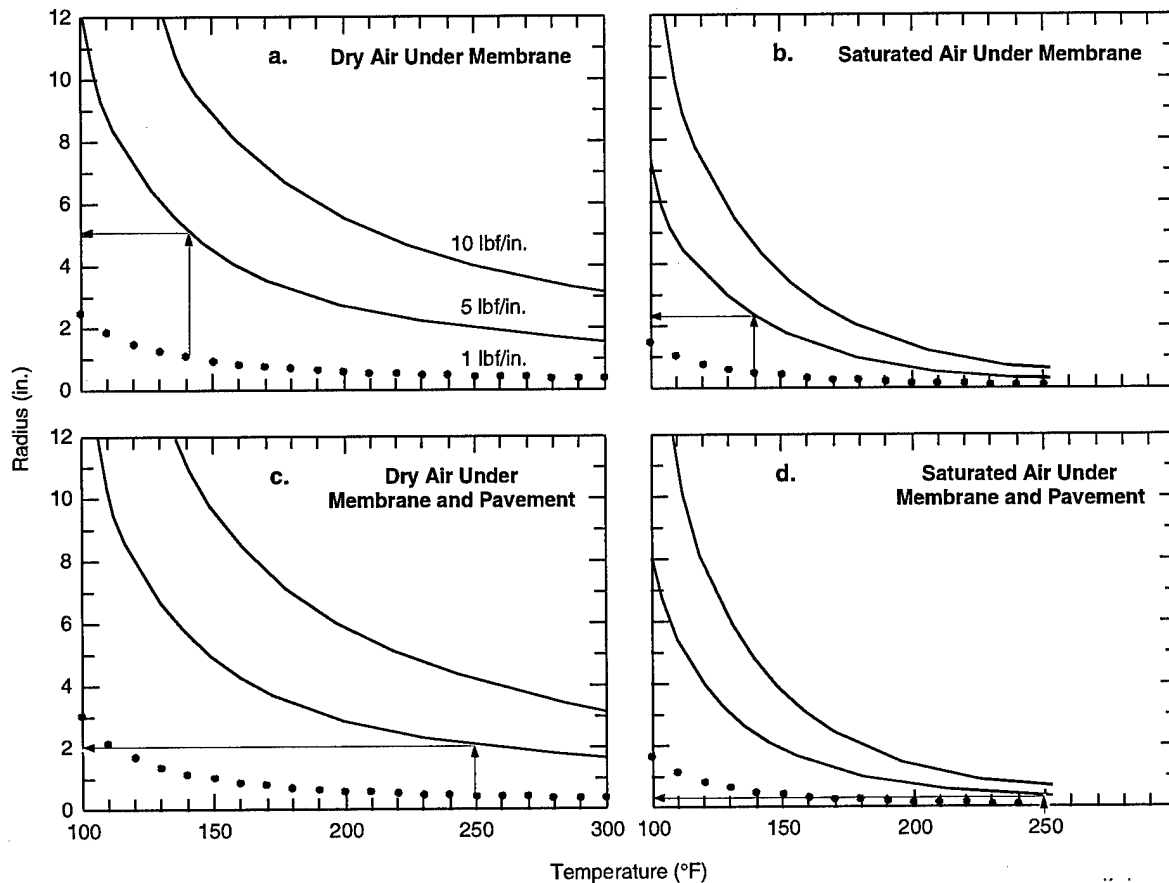
Figure 3, developed from eq 2, illustrates this concept. It consists of four graphs, each composed of three curves, where each curve represents peel strength plotted against temperature and critical size. Each graph defines the smallest void expected

to blister. For example, if an air pocket beneath a membrane adhered to a deck at 5 lbf/in. (875 N/m) is heated from 70° to 140°F (24° to 67°C), a 5.2-in. (13.2-cm) radius would be the smallest void that could blister (Fig. 3a). However, if the air beneath the membrane is continually water saturated, the critical void would reduce to 2.25 in. (5.7-cm) radius (Fig. 3b). Of course, higher bond strengths are more resistant to blistering, but one must realize that heat, the driving force of blisters, softens the adhesive and diminishes peel strength. Thus, the 5-lbf/in. force used in the above analogy is considered conservative, even though some membranes adhere more tightly to concrete at room temperature.

Figure 3. Relationship between minimum void size, peel strength, and internal void temperature. Blister pressure, which relates to temperature, was determined by considering dry and moist air to be ideal gases. The temperature of 70°F (21°C) represents atmospheric pressure.

its overburden increases more than 20-fold (a membrane weighs between 0.002 to 0.008 lb/in.<sup>2</sup> whereas 2-in.-thick asphalt pavement weighs approximately 0.168 lb/in.<sup>2</sup>). In this situation we see that the critical size changes from a 2.1-in. (5.3-cm) radius when the void space is dry (Fig. 3c) to a 0.30-in. radius when it is wet (Fig. 3d). Moreover, blisters do not just expand once, they continually increase in size. Korhonen (1986) found this to be true for roof blisters as did Hironaka and Holland (1986) for pavement blisters. Thus, once a blister initiates, no matter how small it may be, it eventually grows large enough to become a big problem.

Though Figure 3 represents idealized situations (a blister is not rigid and self-contained), clearly a nonporous membrane exposed to the sun will remain blisterless if its voids are smaller than 5.5 in. (14 cm) across (Fig. 3b). When exposed to the intense heat of freshly laid pavement, approximately quarter-sized voids (0.9 in., or 2.4 cm) (Fig. 3d) can lead to problems. Other scenarios are possible for blisters but the quarter coin size should be useful as a rule of thumb for bridge inspectors to distinguish when a membrane is being inadequately adhered to a deck. A permeable membrane can reduce blistering by allowing pressure build up to escape through the membrane. However, the section on water vapor permeance reveals that the membranes in this study were not very breathable.

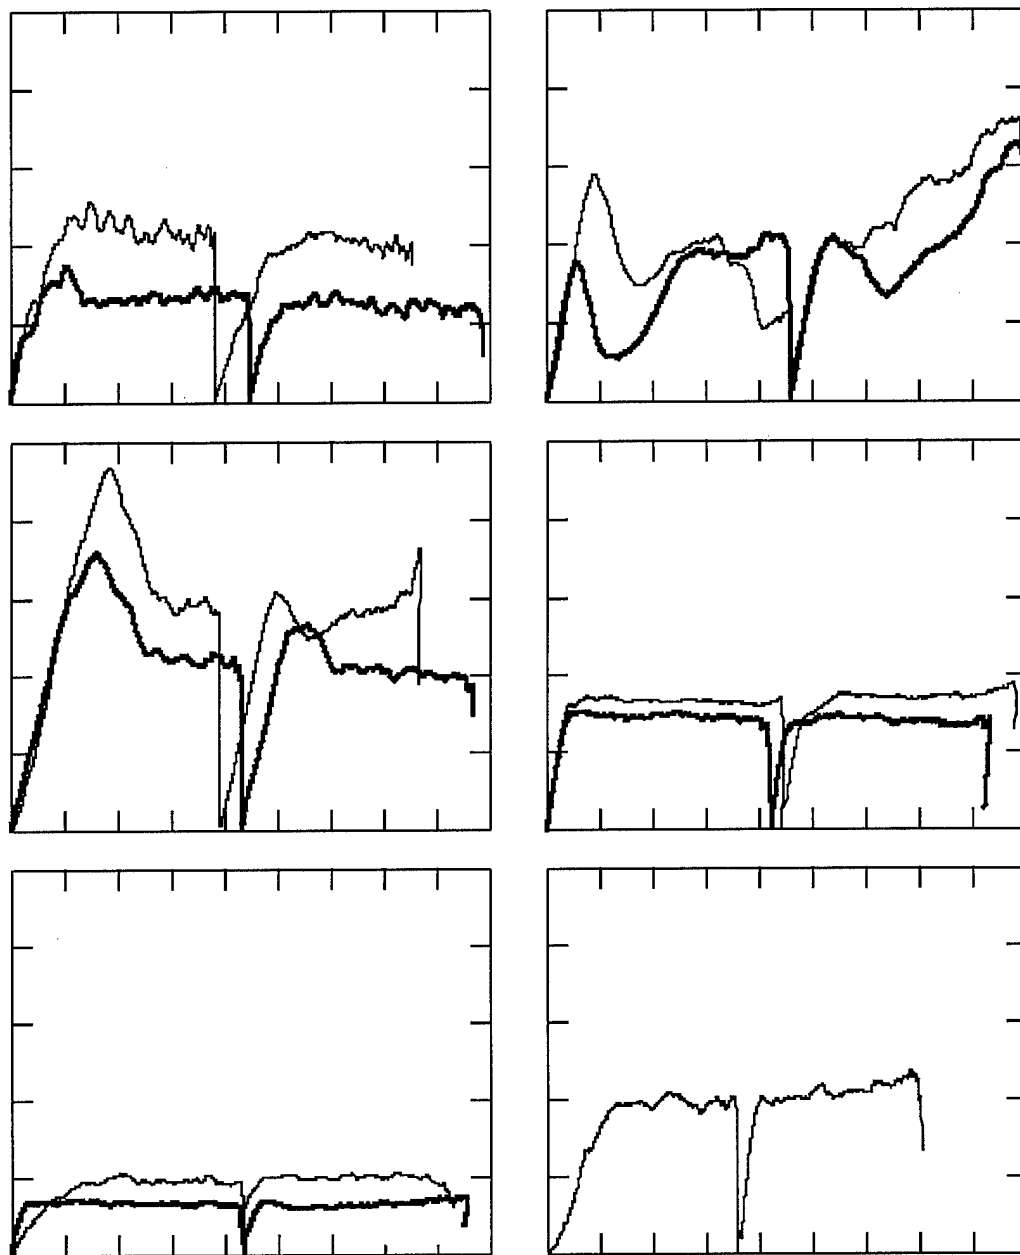
Figure 4 shows six force-displacement diagrams, one for each membrane type where each is composed of two curves (except for Figure 4f, where supplier samples were not available). As can be seen by the difference between the two curves in each graph, the choice of applicator can influence results. Each curve represents the average of up to 15 strips peeled from three samples fabricated by the membrane supplier compared to three done by CRREL. The Figure 4 curves reveal that testing was done in two stages. In the first stage, approximately 2 to 2.25 in. (5.7 cm) of the membrane was peeled off the slabs. The membrane was then unloaded, repositioned in the grips—as the grips reached the end of their move-

*Figure 4. Adhesion test results. Each curve is the average of up to 15 test strips. Surprisingly, the CRREL samples consistently developed high overall, but low individual, adhesion values (Fig. 4 vs. App. B).*

The entire data set for the adhesion tests consists of force-displacement diagrams for 157 strips of membrane peeled off mortar slabs (App. B). We will not discuss each diagram but, rather, summarize them in Figure 4 and make specific references to them in the following text to give the reader a sense of their significance. The reader is encouraged to peruse Appendix B for added detail.

ment—and peeled approximately another 2 in. (5 cm). In interpreting the curves, one should recognize that the pulling force for each stage gradually built up, as the membrane and adhesive stretched and as the membrane seated in the grips, until the force became large enough to progressively peel the membrane from the slab.

Here, the Protecto Wrap and W.R. Grace membranes become the membranes with the least potential problems. They exhibit moderate, but very uniform, adhesion values with little indication of weak spots (Fig. 4a and 4d). Interestingly, the Protecto Wrap membrane seemed the least influenced by the source of the samples for testing. This uniformity suggests that this membrane would
